Visual Property Inspection

Sample Report

Property Address Sample Report
City Piscataway State NJ Zip 08854

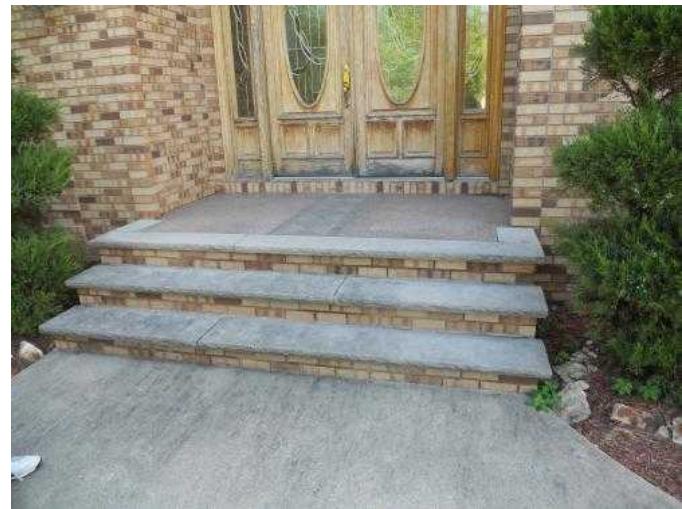
Acceptable	Driveway: Concrete
Acceptable	Walks: Concrete
Informational	Steps/Stoops: Brick, Concrete slab We recommend adding handrails as a safety measure.

1. Steps/Stoops: Brick, Concrete slab We recommend adding handrails as a safety measure.
Exterior Surface and Components

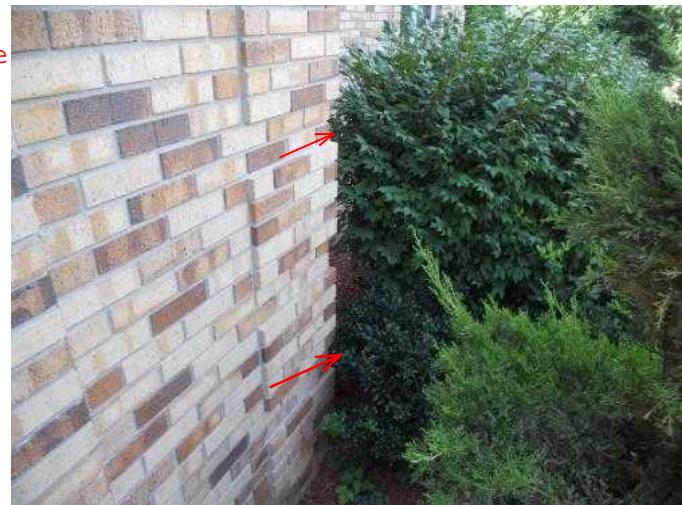
Repair or Replace	Vegetation: Shrubs Shrubs, trees and plant life should always be kept trimmed back to one foot away from the home to reduce the risk of having them become intrusive to the structure of the home itself. Shrubs need to be trimmed back.
-------------------	--

1. Grading: Negative slope **Grading has negative slope and water is pooling against the foundation. Fill dirt needs to be added to ensure that water drains away from the home.**
2. Vegetation: Shrubs **Shrubs, trees and plant life should always be kept trimmed back to one foot away from the home to reduce the risk of having them become intrusive to the structure of the home itself. Shrubs need to be trimmed back.**
3. Window Wells: Not covered **The window wells were not covered and require a cover as a safety precaution.**

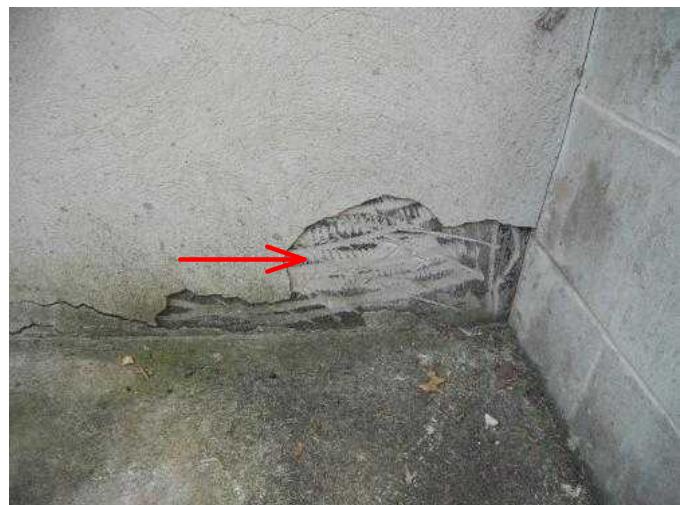
Repair or Replace Type: Brick veneer, Vinyl siding, Stucco **The stucco at the east side of the home is cracked and requires repair.**

4. Whole house Exterior Surface Type: Brick veneer, Vinyl siding, Stucco **The stucco at the east side of the home is cracked and requires repair.**
5. Entry Doors: Wood **The front door has water damage and is beginning to rot. The door requires stain and water sealing.**
6. Windows: Vinyl casement **the basement window on the east side of the house has rotted trim and the trim requires replacement.**

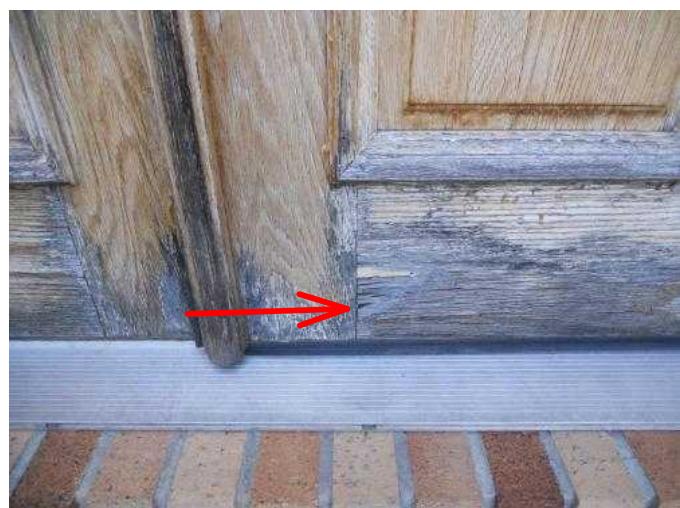
Acceptable Trim: Wood, Aluminum, Vinyl
Acceptable Fascia: Wood
Acceptable Soffits: Vinyl
Acceptable Door Bell: Hard wired
Repair or Replace Entry Doors: Wood **The front door has water damage and is beginning to rot. The door requires stain and water sealing.**

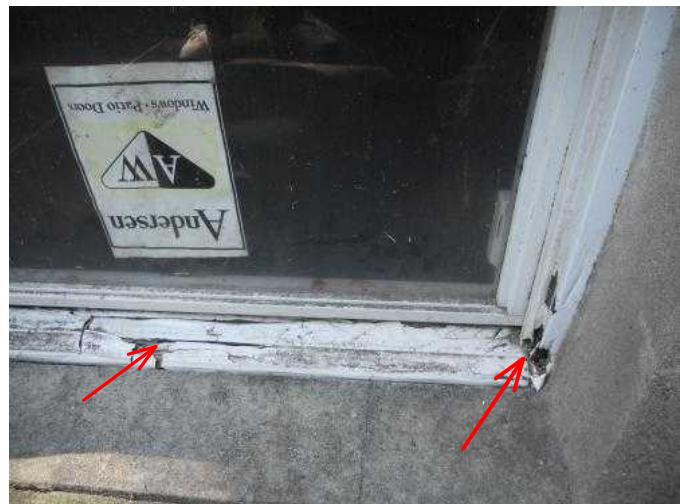
Repair or Replace Windows: Vinyl casement **the basement window on the east side of the house has rotted trim and the trim requires replacement.**

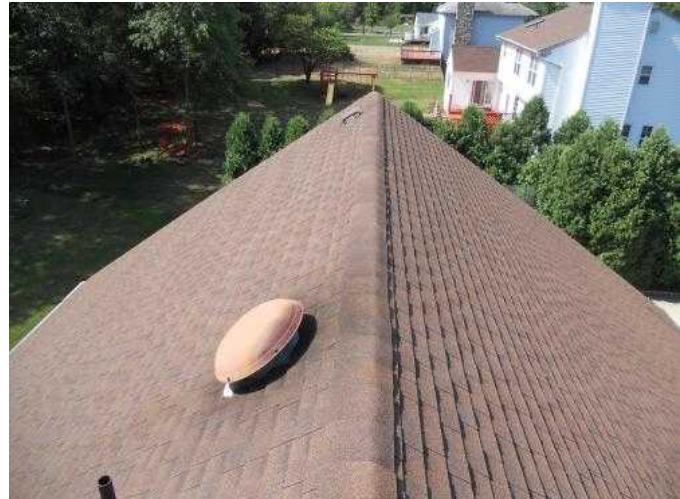
Method of Inspection: We evaluated the roof and its components by walking on its surface.

Unable to Inspect: 50% The roof is in acceptable condition, but this is not a guarantee against leaks. For a guarantee, you would need to have a roofing company perform a water-test and issue a roof certification.

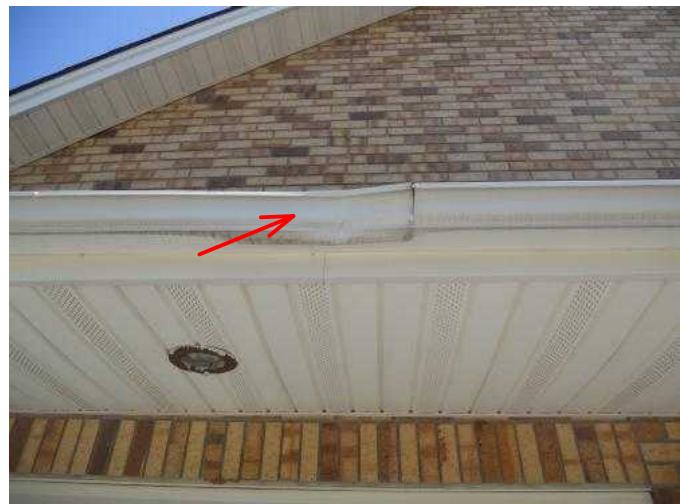
Gutters: Aluminum The gutter is damaged and may require repair.

Gutters will require cleaning periodically to ensure that they drain properly.

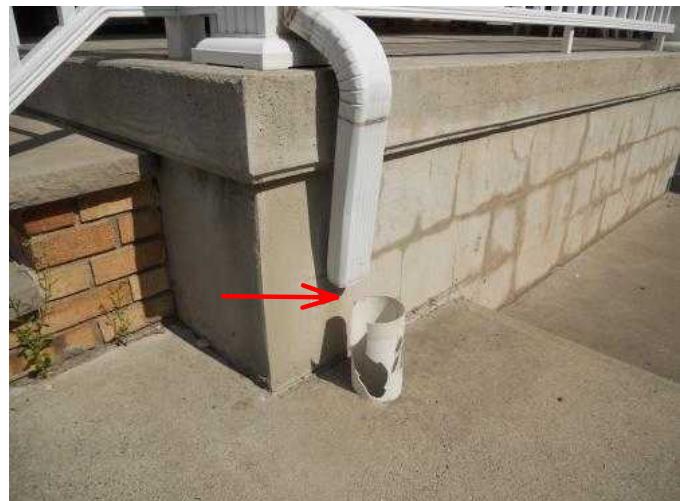
Downspouts: Aluminum The downspout needs to be reconnected to the underground piping.

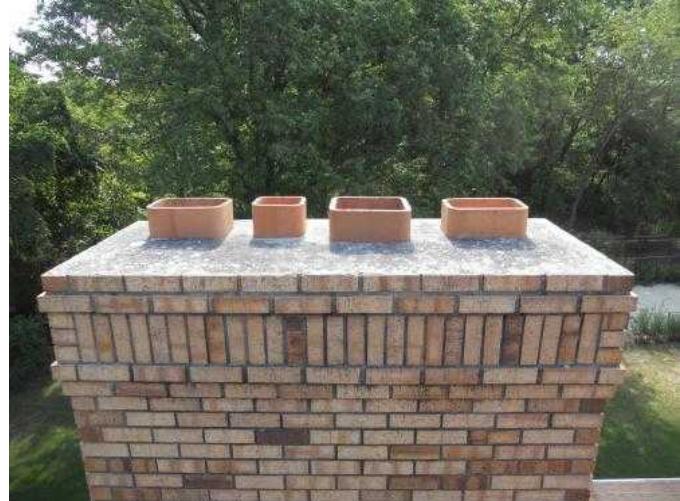
Flue/Flue Cap: Clay Recommend adding rain/snow cap.

5. Main Roof Surface Material: Composition shingle. The typical life expectancy for a composition shingle roof is 15-25 yrs.
6. Skylights: Insulated glass Evidence of past water leakage. This area should be monitored and repaired/replaced when necessary.
7. Gutters: Aluminum The gutter is damaged and may require repair. Gutters will require cleaning periodically to ensure that they drain properly.
8. on roof Chimney Flue/Flue Cap: Clay Recommend adding rain/snow cap.

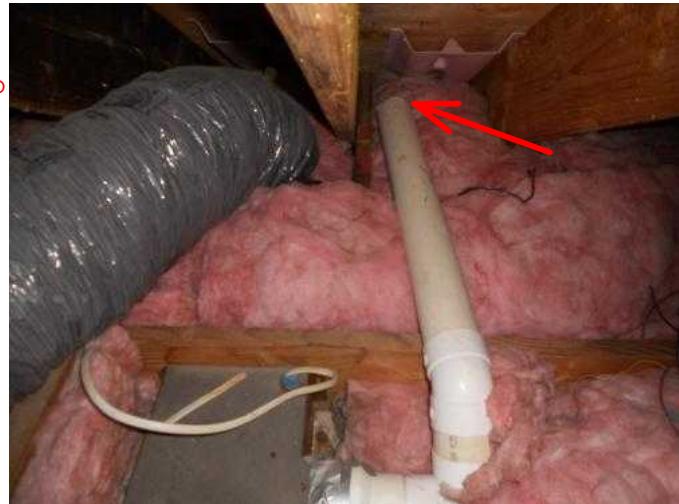
Acceptable	Unable to Inspect: 70%
Acceptable	Roof Framing: 2x10 Rafter
Acceptable	Sheathing: Plywood
Acceptable	Ventilation: Roof and soffit vents, Thermostat controlled Power Vent
Acceptable	Insulation: Batts
Acceptable	Wiring/Lighting: 120 volt lighting circuit
Repair or Replace	Bathroom Fan Venting: Electric fan <i>The bathroom fans improperly vent into the attic and need to be terminated to the outdoors.</i>

8. Main Attic Bathroom Fan Venting: Electric fan **The bathroom fans improperly vent into the attic and need to be terminated to the outdoors.**

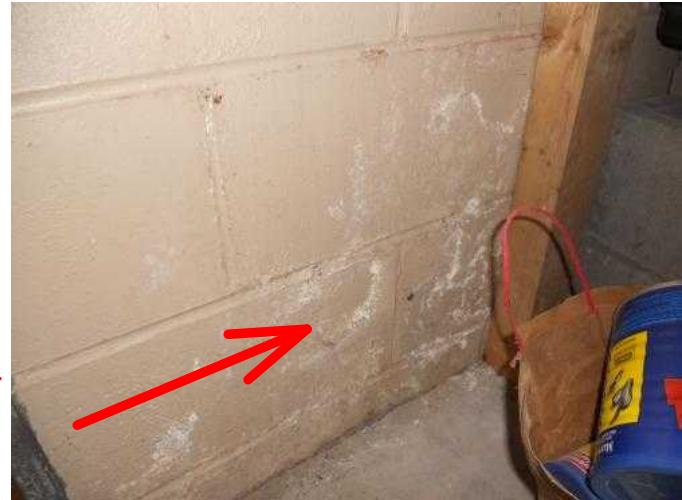
Repair or Replace Moisture Location: At the base of foundation wall There is efflorescence on the basement walls, which confirms that moisture has penetrated the area and activated minerals that form a white powdery formation of salt crystals. With the recent concerns about mold, this is a condition that should be monitored, and one that could produce musty odors.

9. Main Basement Moisture Location: At the base of foundation wall **There is efflorescence on the basement walls, which confirms that moisture has penetrated the area and activated minerals that form a white powdery formation of salt crystals. With the recent concerns about mold, this is a condition that should be monitored, and one that could produce musty odors.**

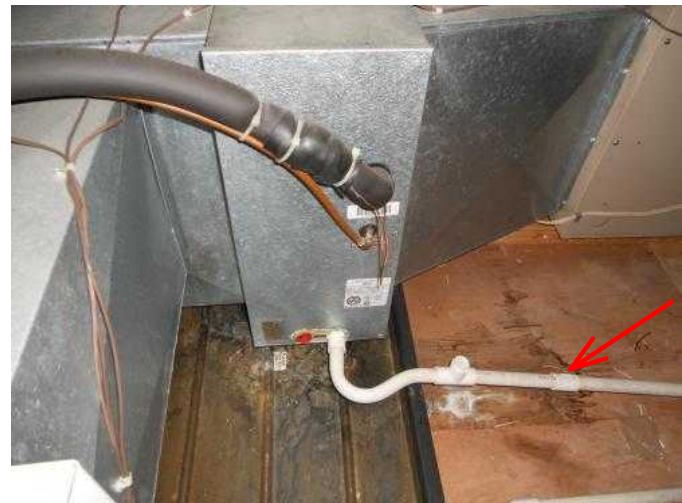
Repair or Replace Condensate Removal: PVC The Condensate line in the attic appears to be leaking and requires further evaluation.

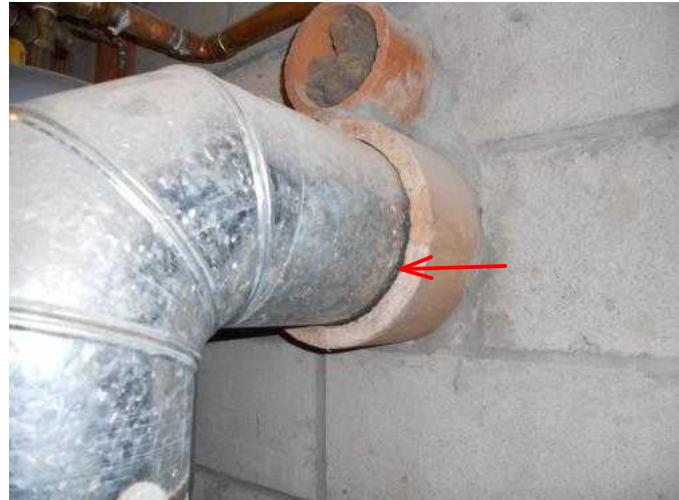
Repair or Replace Flue Pipe: Metal Seal vent
penetration into wall/chimney

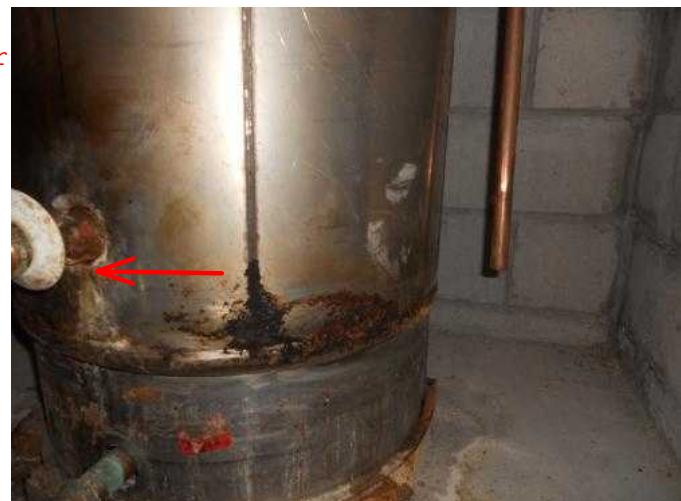
Repair or Replace **Water Heater Operation:** Functional at time of inspection **The water is heated by the boiler and held in a hot water tank located in the basement.**

The boiler connection appears to be leaking and requires further evaluation.

The boiler connection appears to be leaking and requires further evaluation.

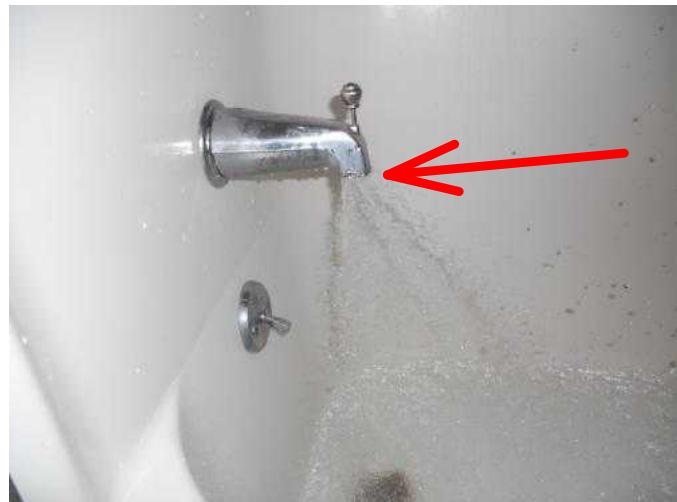
Acceptable	Closet: Small
Acceptable	Ceiling: Drywall
Acceptable	Walls: Drywall
Acceptable	Floor: Ceramic tile, Marble
Acceptable	Doors: Wood
Acceptable	Windows: Vinyl casement
Acceptable	Electrical: 120/240 volt GFCI protected
Acceptable	Counter/Cabinet: Composite and wood, Granite
Informational	Sink/Basin: Molded single bowl, Molded dual bowl The sink in the master bath is rusting and the water lines appeared to have leaked in the past. These areas should be monitored and repaired/replaced as necessary.
Repair or Replace	Faucets/Traps: Drain, Faucet The diverter in the rear upstairs bathroom and the downstairs bathroom are not working properly and requires repair.

16. Bathrooms Bathroom Faucets/Traps: Drain, Faucet The diverter in the rear upstairs bathroom and the downstairs bathroom are not working properly and requires repair.

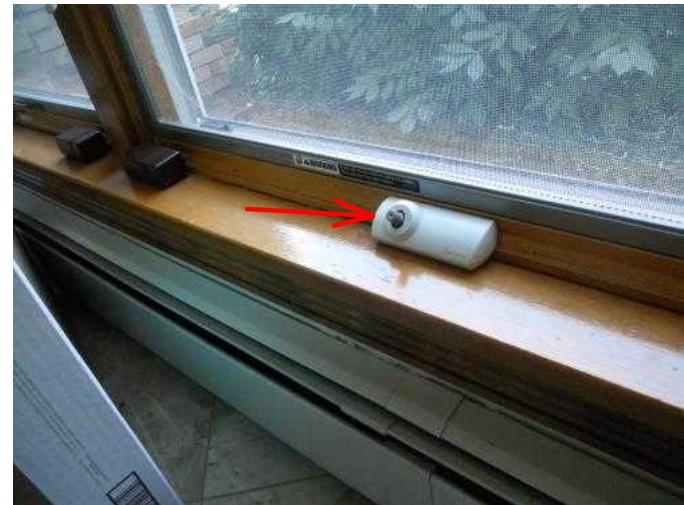
Repair or Replace Windows: Vinyl casement Many of the windows throughout the house had missing hardware and require repair to work properly.

21. Bedrooms Bedroom Windows: Vinyl casement Many of the windows throughout the house had missing hardware and require repair to work properly.

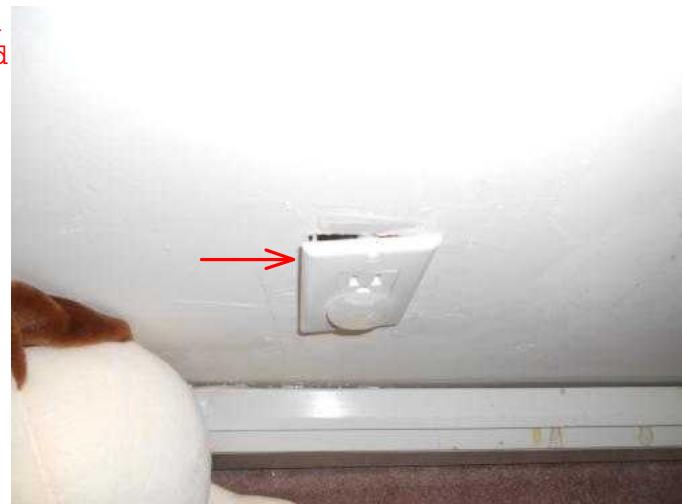
Repair or Replace Electrical: 120/240 volt **the outlet in the family room is loose and needs to be secured.**

25. Living Space Living Space Electrical: 120/240 volt the outlet in the family room is loose and needs to be secured.

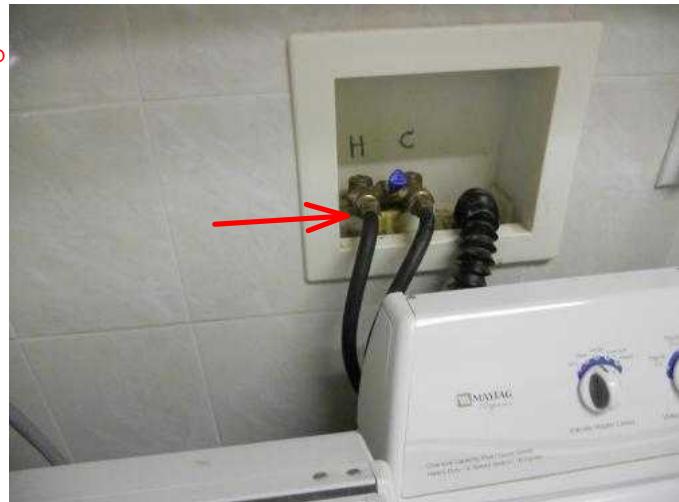
Repair or Replace Washer Hose Bib: Ball valves The rubber hoses have been known to burst, and must be replaced with the metal braided type.

26. Main floor Laundry Room/Area Washer Hose Bib: Ball valves The rubber hoses have been known to burst, and must be replaced with the metal braided type.

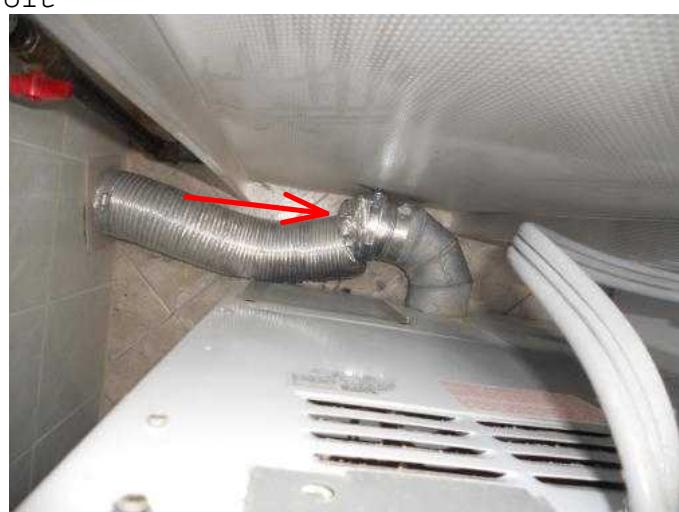
Acceptable Repair or Replace Washer and Dryer Electrical: 120/240 volt
Dryer Vent: Metal flex The metal vent line is crushed and requires replacement.

27. Main floor Laundry Room/Area Dryer Vent: Metal flex The metal vent line is crushed and requires replacement.
